APPLICATION AND VERIFICATION OF RDA

1. Selected Rockslope Deterioration Assessments

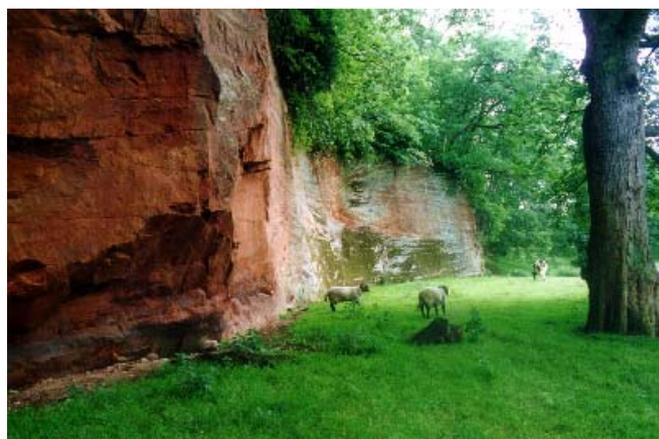
Bongate Scar is a very old, hand excavated quarry situated at the edge of the floodplain of the River Eden in Cumbria at grid reference NY 687199 (Plate 1). The rock is a medium grained, uncemented, friable, slightly weathered, weak SANDSTONE with characteristic red coloration due to haematite coating of grains. The rocks are part of the Penrith Sandstone formation of Permian age. The structure consists of very large scale dune cross bedding with occasional vertical joints. The slope is mostly uniform, but contains some very localised intensely fractured zones. For clarity, the latter are not considered in the RDA presented.

Plate 1 General view of Bongate Scar

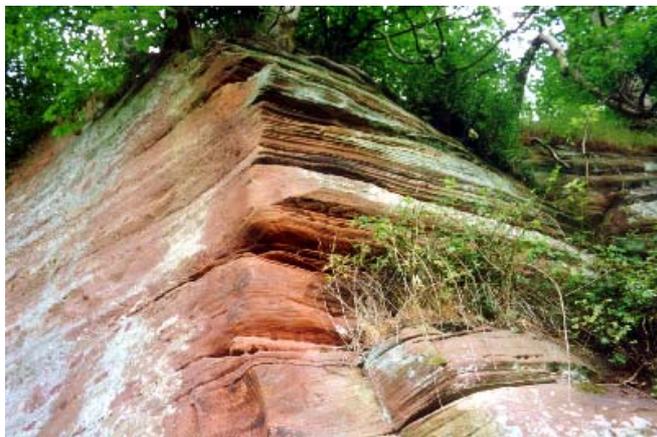
Environmental conditions: The slope is located at an altitude of 145m AOD. It has a west to north west aspect and is situated in an extremely sheltered valley bottom environment, surrounded by mature trees. The slope therefore receives little direct sunlight and appears to remain damp for much of the time. A widespread cover of moss and algae on parts of the rock surface is further evidence of this. There is no seepage present but waterflow exists in the form of closely spaced laminations being picked out by wash erosion (Plate 2).

Plate 2 Evidence of water flow

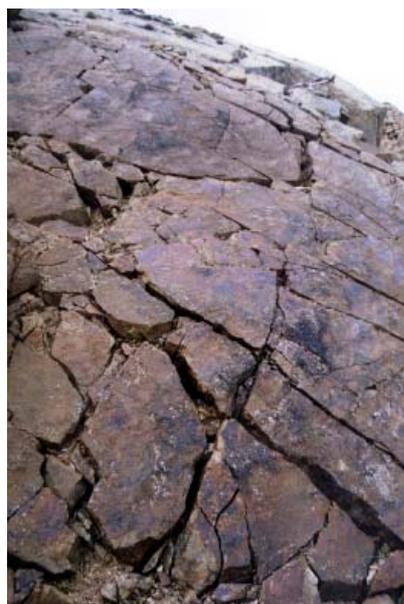
Knock Pike is a disused, bulk blasted quarry situated near Appleby in Cumbria at grid reference NY 687286. The rock is an ash flow unit with eutaxitic texture, formed from intense compaction of pumice fragments contained within. It is a fine crystalline, well cemented, slightly weathered, very strong IGNIMBRITE. The sequence is of Ordovician age, of the Knock Pike Tuff formation (Borrowdale Volcanic Group). The rock mass is dominated by random, blast-induced fractures and irregular joints, giving an irregular blocky structure overall (Plate 3).

Plate 3 Blast induced fractures at Knock Pike Quarry

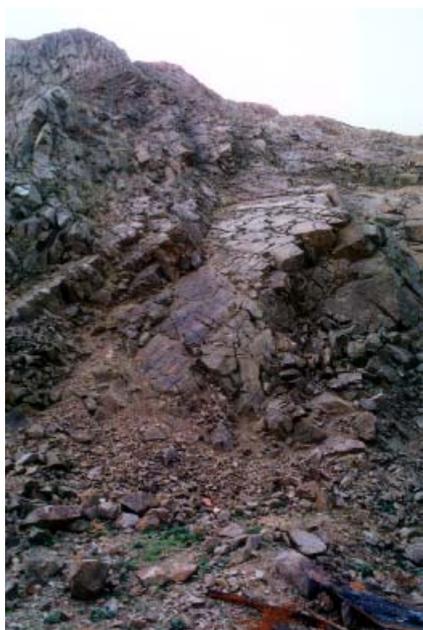
probably the source of large, associated rockpiles from rockfalls (overhang collapse). Irregular structure chutes are also present, feeding large debris piles at the foot, indicating debris flow (Plate 4). There are poorly developed levee structures and lobe-like deposits associated with these. The slope also has a number of large, perched blocks indicating potential for stonefall and blockfall, varying length ledges acting as structural chutes, and evidence of block wedging in wide aperture fractures. In some areas, blocks are tightly interlocking, so although closely fractured, they appear stable. Observations of erosional and depositional landforms suggest that while generally stable, the rock mass structure is such that when deterioration by fall is triggered in an area, this releases a large volume of material to collapse also. Thus the principal deterioration modes are stonefall, rockfall and debris flow. There might also be some stone ravelling but evidence is hidden in the irregularity of the slope and the large amount of debris from the large magnitude events.

Plate 4 Knock Pike Quarry
Structure chutes with debris piles at the foot

Reference to the deterioration mode data sheets should enable assessment to be made of the most appropriate mitigation measures for this slope. The recommended treatment for this slope would be scaling of perched blocks; protective measures (large rockfall ditch and reinforced or anchored fencing or barrier); regular debris clearance, inspection and monitoring; cut-off drain at the crest; underpinning of overhangs; local dentition or buttressing; and dowel reinforcement of key blocks. Local application of wire netting might also be helpful in areas where only stone ravelling is occurring (i.e. none of the large magnitude events are in evidence).

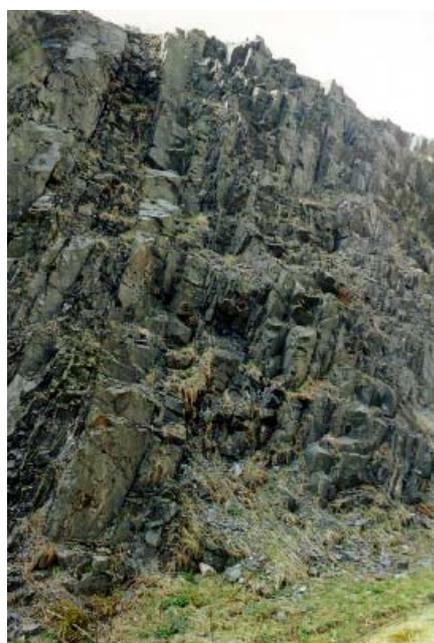
The cutting at Dillicar on the M6 in Cumbria is situated at grid reference NY 610002. The rock is a fine to medium grained, moderately (fissile areas) to strongly (layered areas) cemented, fresh to slightly weathered, strong to very strong METASEDIMENT, consisting of a slightly metamorphosed turbidite sequence with interbedded siltstone and fine sandstone. The sequence is of Upper Silurian age, of the Coniston Grits formation. The structure consists of inter-layered competent sandstones and siltstones, with fissile shaley layers (Plate 5). The overall rock mass could therefore be described as composite (layered), but the two zones (fissile and layered) have been evaluated separately.

Plate 5 M6 Dillicar
Interbedded competent sandstone
and fissile shaley layers

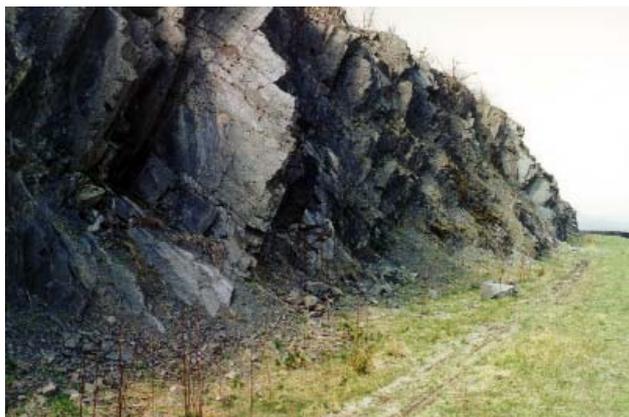
Layered/blocky slope: This part of the slope generally fits into the layered type but there are also regular blocky areas within it. The relevant data sheets indicate a typical RDA_A Class for metamorphic rocks of 1 to 3 (layered) and 2/3 (regular blocky). For layered slopes, major deterioration modes can be expected to be stonefall and stone ravelling, with minor modes of wash erosion and blockfall. Grain ravelling, flaking and rockfall might also occur. For regular blocky slopes, stone ravelling is also a major mode, with minor modes of stonefall, blockfall and rockfall. Minor modes include grain ravelling, flaking and wash erosion. Field observation showed that structural chutes were common, often with piles of stones at the foot indicating stone ravelling and small rockfalls (Plate 6). The latter were also indicated by several large rockpiles including blocks of 30 to 40cm. A general scatter of isolated stones and blocks at the foot indicated that stonefall and blockfall had also occurred (Plate 6). There was also evidence of draped grass on the slope indicating wash erosion.

Plate 6 General view of M6 Dillicar showing the range of debris at the slope foot

Layered/blocky areas: Regular debris clearance and removal of woody shrubs; crest drainage and inclined drainholes at critical slope locations; containment using rocktrap ditch and fencing; local wire mesh netting for areas of stonefall and ravelling, with dowel reinforcement of key blocks for areas prone to blockfall. *Fissile areas:* As for layered/blocky areas (since these two zones are part of the same slope), and toe and slope drainage; very close mesh wire or plastic netting for areas with flaking; shotcrete or local mortar screeding for small, weak areas; dentition for small overhangs; and shotcrete sealing of fracture and erosion chutes.
